B&B Benchmark

B&B ELECTRIC MOTOR CO. Wichita, Ks

OCTOBER 2003

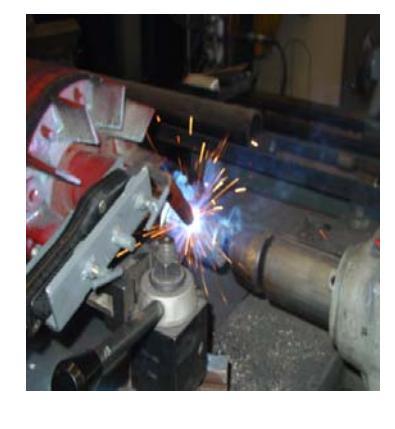
MACHINE WORK

With the wide variety of machine work that we provide, it becomes very important to maintain the correct equipment.

B&B has 4 lathes (to accommodate varied sizes of motor armatures) 2 dynamic balancers (one in shop and one portable unit to balance on site) and one vertical mill.

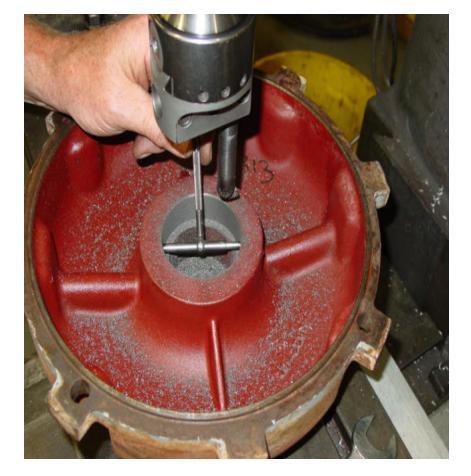
*REPAIR OF MOTOR SHAFTS: This can include mav things: metalizing. welding. milling keyways, cutting threads and machining shaft to the correct diameter. We have a unique semi automatic welding process to repair shaft and bearing surfaces. No other repair shop in the area can perform this type of repair. We can weld steel or stainless shafts. It is sometimes necessary, especially if the shaft is bent, to cut the end of the shaft off & stub a new shaft. This requires welding a new piece of material on to the cut shaft and then machining it to size.

***BALANCING:** The object of balancing is to eliminate the amount of vibration in a motor. This requires balancing all rotating parts. Our equipment measures the movement so that weight can be added or removed to the rotating parts, thus reducing the amount of vibration.

***BORE & SLEEVE ENDBELLS** Sometimes normal wear will cause the endbell to become to large for the bearing. A cast iron sleeve can be placed in the endbell and then bored to the correct diameter.
